# Pre-Purchase Building Inspection

4 The Street Moorabbin

Prepared for: John Citizen

**Report Purpose:** Pre-Purchase Building Inspection:

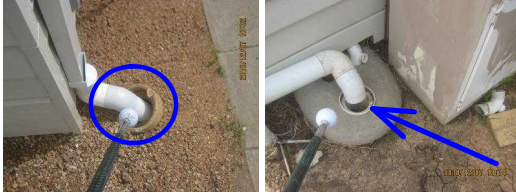
FAIR CONDITION: **DOWNPIPES:** Poor connection to storm water drains: Vulnerable to blockage and/or leakage to foundational areas: Plumbing assessment recommended:

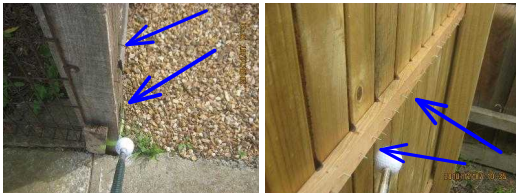
FAIR CONDITION: **FENCING:** Protruding Nails: Dangerous: Carpentry assessment recommended: **Front Yard Area:**

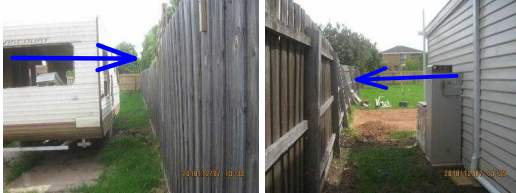
POOR CONDITION: **FENCING:** Fencing leans: Fencing assessment recommended:

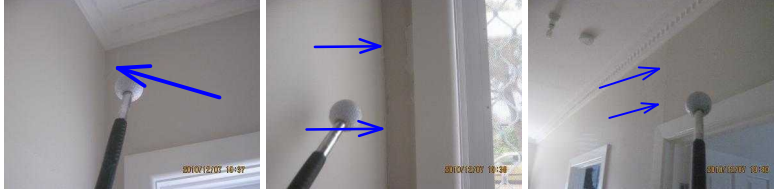
FAIR CONDITION: **INTERNAL WALLS:** Minor seam cracks: These hairline cracks usually appear where there has been minor movement to joins in plasterboard and/or cornices: These are usually a minor issue requiring basic repairs only: A qualified plasterer and/or painter would be best suited to assess these issues:

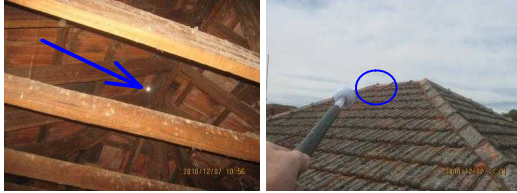
**FAIR CONDITION:** ROOF UNDERSIDE: Daylight can be seen through ridge top: Vulnerable to leakage: Roofing assessment recommended:

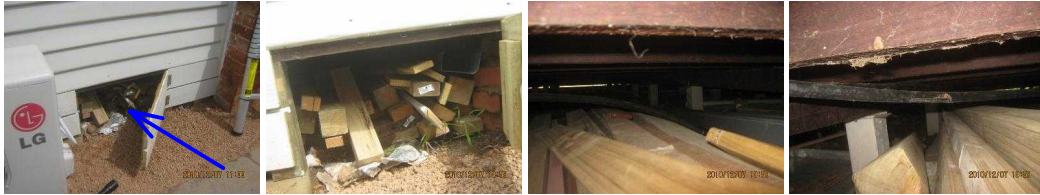
**NOTED:** ACCESSIBILITY: Stored items restricted access to the sub-floor areas:

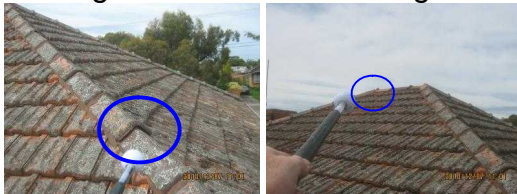
**FAIR CONDITION:** ROOF TILES: Ridge mortar: Minor deterioration and/or cracks to ridge mortar: Leakage could occur: Roofing assessment recommended:
