Hand Over Building Inspection

4 The Street Moorabbin

Report Purpose: New Home Pre-Settlement Condition Report:

Inspection Date: 10th December 2010

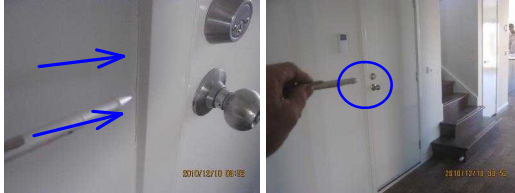
Location: Front Entrance:

FAIR CONDITION: INTERNAL WALLS: Minor imperfections to painting finish: Re-paint recommended:

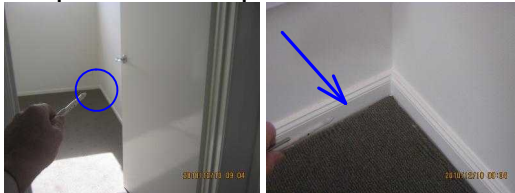
Location: Upstairs: First on left:

FAIR CONDITION: SKIRTING/JAMBS/TRIMS: Minor imperfections to painting finish:
Re-paint/touch-up recommended:

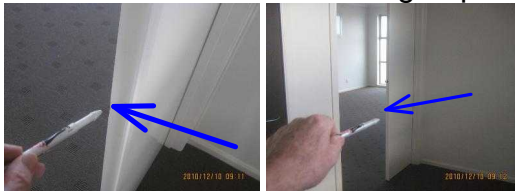
Location: Upstairs: Last on left:

FAIR CONDITION: DOORS: Poor and/or damaged paint work: Re-paint recommended:

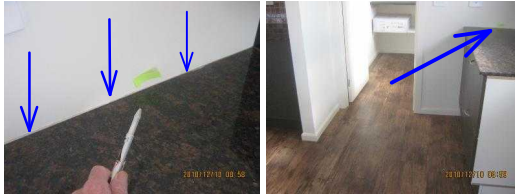
FAIR CONDITION: CUPBOARDS: Minor paring of sealant at cupboard and wall fixing area: Painting assessment recommended:

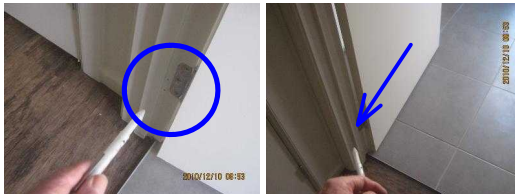
FAIR CONDITION: SKIRTING/JAMBS/TRIMS: Poor and/or damaged paint work: Re-paint recommended:

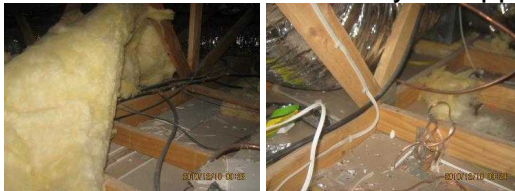
FAIR CONDITION: INSULATION & SARKING: Untidy installation of insulation: Areas of roof void are not covered: Assessment by an appropriate and qualified contractor recommended:

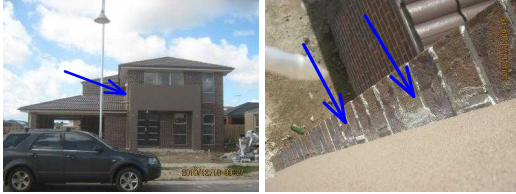
FAIR CONDITION: WALL SURFACES: Cleaning: It is my opinion that areas of the brickwork perpend's have not been cleaned sufficiently: Some areas are unsightly in my opinion: Brick cleaning assessment recommended: Have all areas assessed:

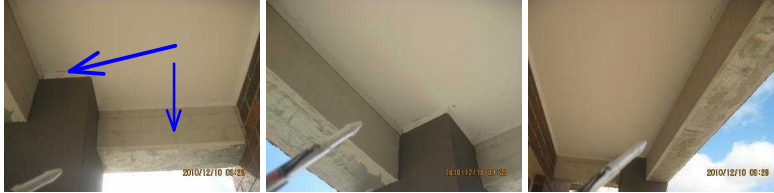
NOTED: INTERNAL CEILINGS: Incomplete painting evident: This was consistent to various areas throughout:
